15-04 - Surefire X300 Ultra Weapon Mounted Light

Los Angeles County Sheriff's Department

SUREFIRE X300 ULTRA WEAPON MOUNTED LIGHT

OFFICER SAFETY ALERT

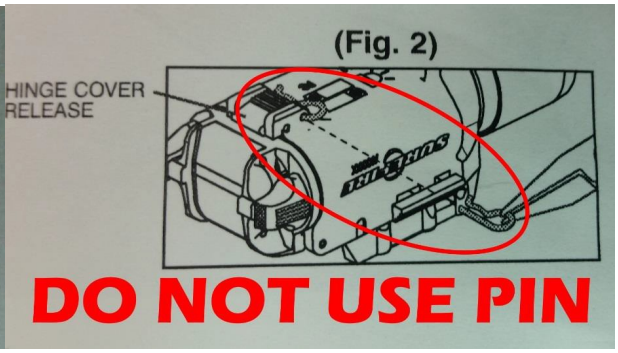
During a recent training session, a recruit was unable to draw his firearm from the holster. It was discovered that the recruit had installed the manufacturer-supplied cotter pin on the battery cover of his Surefire X300 Ultra weapon mounted light. This cotter pin backed out and prevented the recruit from being able to draw his firearm.

The X300 should be installed on the M&P handgun WITHOUT the cotter pin. The X300 back plate is held in place by the M&P trigger guard when it is installed on the pistol. In other words, the back plate release cannot be accidentally activated, even if depressed, while it is mounted on the M&P. Therefore, the cotter pin serves no purpose when the light is used on the M&P pistol. The purpose of the cotter pin is to secure the back plate door when it is used in other capacities such as a light for a long rifle.

All personnel using a weapon mounted light are strongly encouraged to immediately inspect their Surefire weapon light and remove the above-mentioned cotter pin. Please feel free to contact the Biscailuz Center Range at (323) 267-2730 if you have any questions regarding your equipment.
